# Improving Sustainability Efforts at RTI Facilities

2020 Internship Showcase

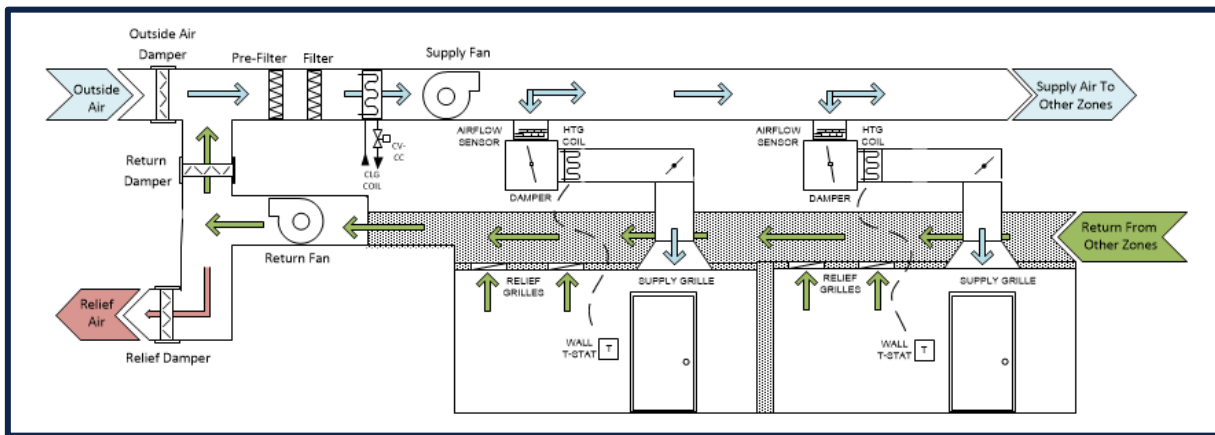
Diagram I created to convey common air handling units for leadership teams

Calculated the outside air needed for an air handling unit at the Herbert Building and modified zones' air supplies
